# Access Compliance Report Public Rights-of-Way (Curb Ramps)

Main Street: TRIAD\_LN Cross Street: AURA\_LN Location: NE

ADA ID: RPRK211028121529 Ramp Type: Type 1 - Perpendicular Initial Pass/Fail: Pass Overall Compliance: No Severity Score: 16

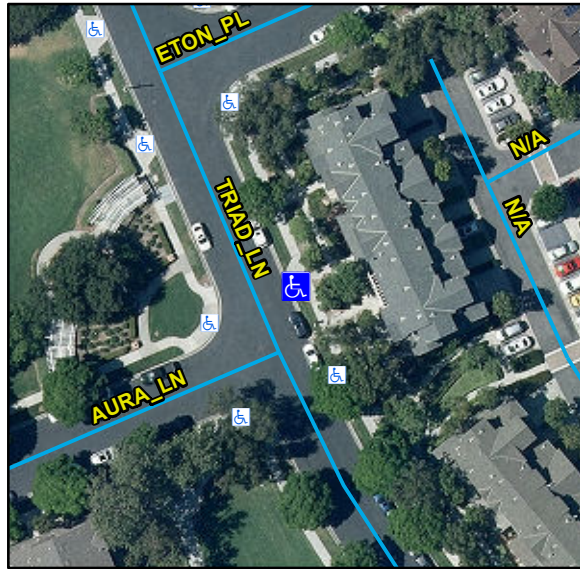
| Compliance | Description | Data | Compliance | Description | Data |
|---|---|---|---|---|---|
| No | Landing Run Slope (%) | 2.2 | N/A | Flare Traversable RT | No |
| Yes | Landing Cross Slope (%) | 2.3 | No | DWS Provided | No |
| Yes | Gutter Ponding | No | No | Curb Slope | 6 |
| No | Gutter Run Slope (%) | 5.6 | | Road Cross Slope (%) | N/A |

Remove & Replace Entire Ramp. Remove & Replace Gutter.
