# Access Compliance Report Public Rights-of-Way (Curb Ramps)

Main Street: AURA\_LN Cross Street: TRIAD\_LN Location: NW

ADA ID: RPRK211028121756 Ramp Type: Type 4 - Parallel Initial Pass/Fail: Fail Overall Compliance: No Severity Score: 15

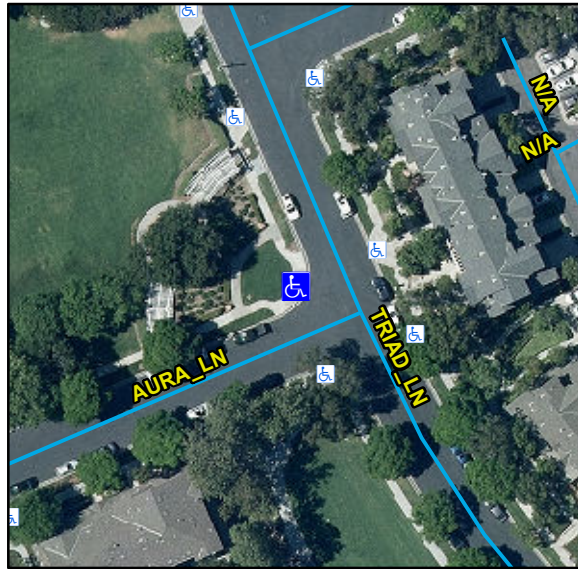
| Compliance | Description | Data | Compliance | Description | Data |
|---|---|---|---|---|---|
| Yes | Ramp Run Slope LT (%) | 1.2 | No | Ramp Run Slope RT (%) | 9.5 |

**Remove & Replace Curb Ramp With Two New Directional Ramps or Equivalent.**

**R204.3, R304.3.2, STD 1115**
