# Access Compliance Report Public Rights-of-Way (Curb Ramps)

Main Street: TRIAD\_LN Cross Street: AURA\_LN Location: SW

ADA ID: RPRK211028122004 Ramp Type: Type 4 - Parallel Initial Pass/Fail: Fail Overall Compliance: No Severity Score: 2

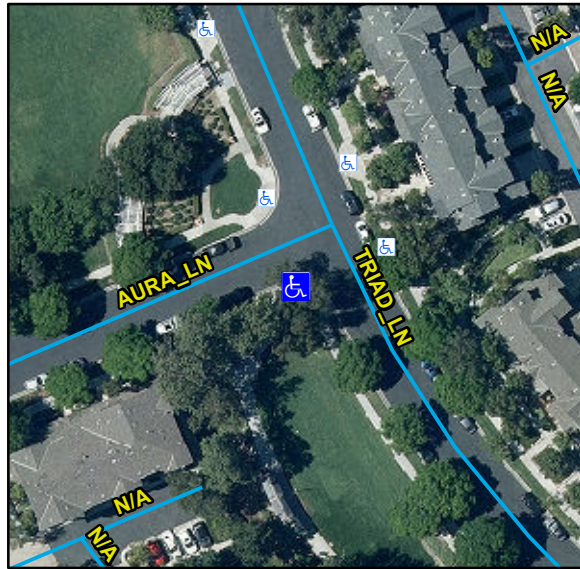
| Compliance | Description | Data | Compliance | Description | Data |
|---|---|---|---|---|---|
| No | Ramp Cross Slope LT (%) | 2.3 | No | Ramp Cross Slope RT (%) | 2.4 |
| N/A | Gutter Ponding | N/A | No | Curb Slope | 13.1 |

Remove & Replace Curb Ramp With Two New Directional Ramps or Equivalent.

R304.2.2, R304.5.3, STD 1115
