# Access Compliance Report Public Rights-of-Way (Curb Ramps)

| Main Street: TRIAD_LN | | Cross Street: N/A | | Location: | NE |

| ADA ID: RPRK211028122316 | Ramp Type: Type 4 - Parallel | Initial Pass/Fail: Fail | Overall Compliance: No | Severity Score: | 2 |

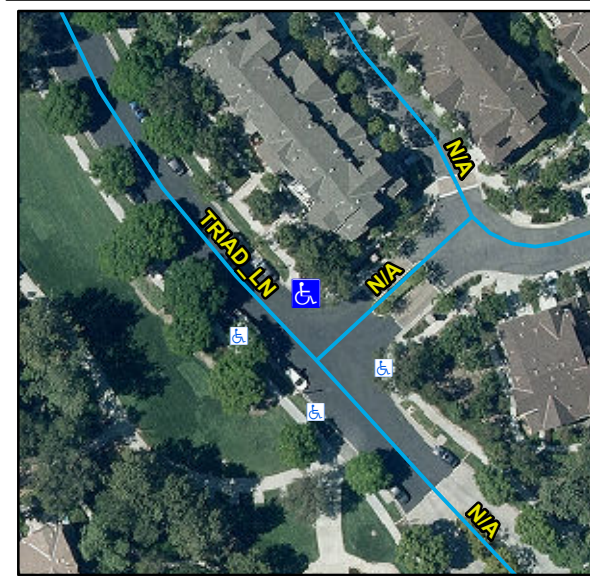
| Compliance | Description | Data | Compliance | Description | Data |
|---|---|---|---|---|---|
| Yes | Ramp Cross Slope LT (%) | 1.2 | No | Ramp Cross Slope RT (%) | 3.5 |

**Remove & Replace Curb Ramp With Two New Directional Ramps or Equivalent.**

**R204.3, R304.5.3, STD 1115**

Total Cost: \$ 4000
