# Access Compliance Report Public Rights-of-Way (Curb Ramps)

Main Street: N/A Cross Street: TRIAD\_LN Location: SE

ADA ID: RPRK211028122530 Ramp Type: Type 4 - Parallel Initial Pass/Fail: Pass Overall Compliance: No Severity Score: 22

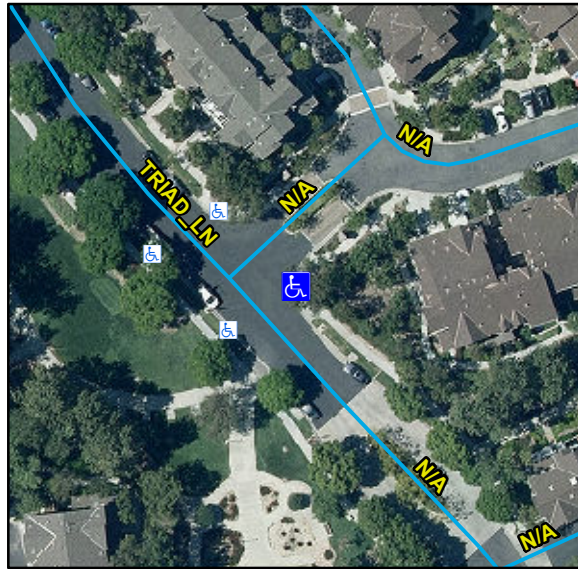
| Compliance | Description | Data | Compliance | Description | Data |
|---|---|---|---|---|---|
| Yes | Ramp Cross Slope LT (%) | 1.6 | No | Ramp Cross Slope RT (%) | 2.2 |
| No | Gutter Cross Slope (%) | 2.8 | No | Perpendicular Joint Present | No |

Remove & Replace Curb Ramp With Two New Directional Ramps or Equivalent. Remove & Replace Gutter.
