# Access Compliance Report Public Rights-of-Way (Curb Ramps)

Main Street: AURA\_LN Cross Street: N/A Location: SE

ADA ID: RPRK211028123122 Ramp Type: Type 4 - Parallel Initial Pass/Fail: Fail Overall Compliance: No Severity Score: 15

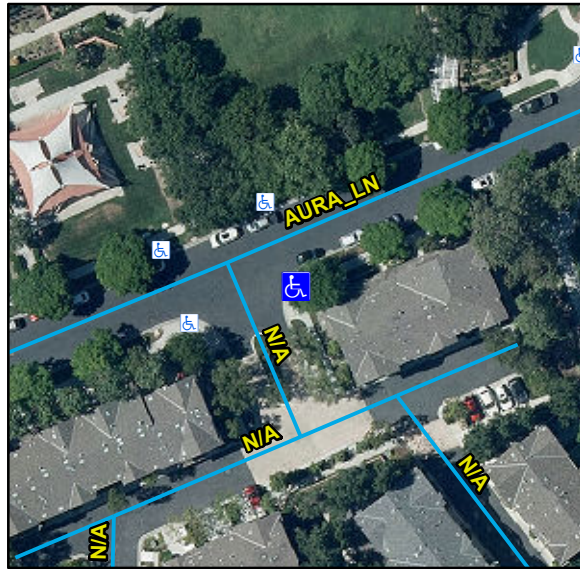
| Compliance | Description | Data | Compliance | Description | Data |
|---|---|---|---|---|---|
| No | Ramp Run Slope LT (%) | 11.8 | Yes | Ramp Run Slope RT (%) | 0.3 |

**Remove & Replace Curb Ramp With Two New Directional Ramps or Equivalent.**

**R204.3, R304.3.2, STD 1115**
