# Access Compliance Report Public Rights-of-Way (Curb Ramps)

Main Street: N/A Cross Street: AURA\_LN Location: SW

ADA ID: RPRK211028123257 Ramp Type: Type 4 - Parallel Initial Pass/Fail: Fail Overall Compliance: No Severity Score: 2

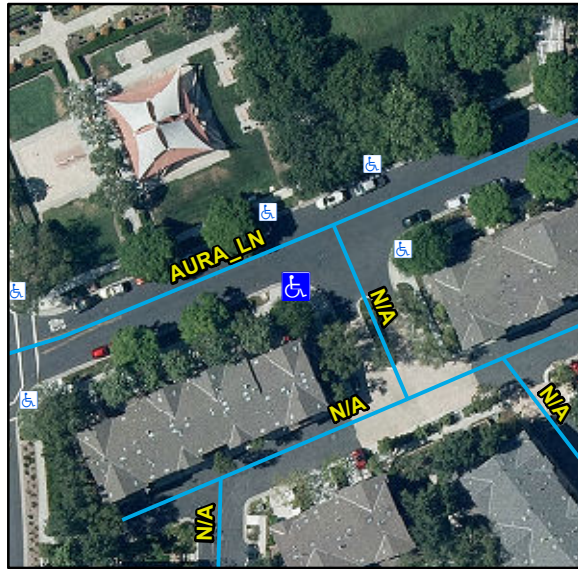
| Compliance | Description | Data | Compliance | Description | Data |
|---|---|---|---|---|---|
| No | Ramp Cross Slope LT (%) | 2.3 | No | Ramp Cross Slope RT (%) | 2.2 |

Remove & Replace Curb Ramp With Two New Directional Ramps or Equivalent.
