# Access Compliance Report Public Rights-of-Way (Curb Ramps)

Main Street: AURA\_LN Cross Street: FOLLATE\_WAY Location: SE

ADA ID: RPRK211028124241 Ramp Type: Type 4 - Parallel Initial Pass/Fail: Pass Overall Compliance: No Severity Score: 25

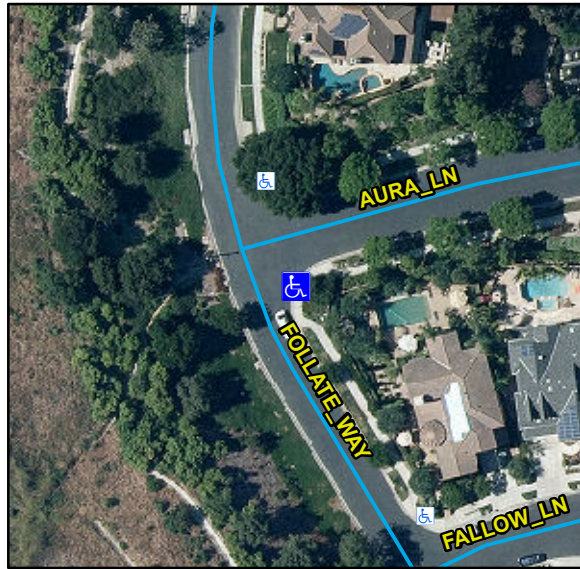
| Compliance | Description | Data | Compliance | Description | Data |
|---|---|---|---|---|---|
| N/A | Landing Present | No | No | DWS Provided | No |
| No | Landing Width (in) | N/A | N/A | DWS Length (in) | N/A |
| No | Landing Run Slope (%) | N/A | N/A | DWS Full Width | N/A |
| No | Landing Cross Slope (%) | N/A | | DWS Offset Type | N/A |
| No | Gutter Run Slope (%) | 9.5 | | Road Cross Slope (%) | 3 |
| No | Gutter Cross Slope (%) | 2.1 | No | Perpendicular Joint Present | No |

Remove & Replace Curb Ramp With Two New Directional Ramps or Equivalent. Remove & Replace Gutter.
