# Access Compliance Report Public Rights-of-Way (Curb Ramps)

| Main Street: FOLLATE_WAY | | Cross Street: FALLOW_LN | | Location: | NE |
| ADA ID: RPRK211028124611 | Ramp Type: Type 4 - Parallel | Initial Pass/Fail: Fail | Overall Compliance: No | Severity Score: | 16 |

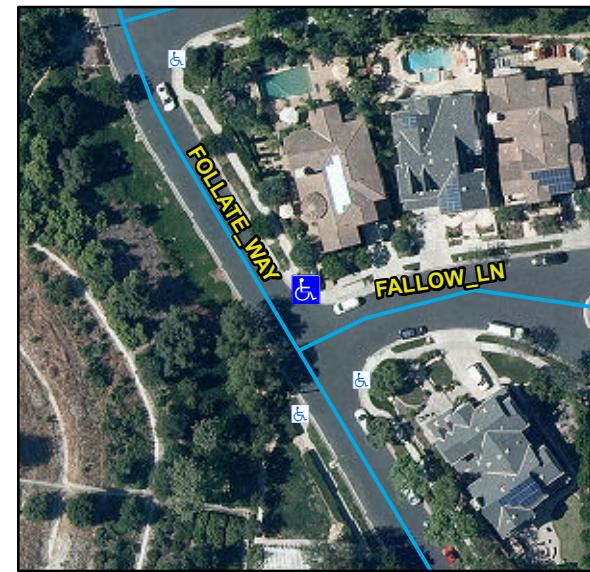
| Compliance | Description | Data | Compliance | Description | Data |
|---|---|---|---|---|---|
| No | Ramp Run Slope LT (%) | 10 | Yes | Ramp Run Slope RT (%) | 2.3 |
| No | Ramp Cross Slope LT (%) | 2.6 | Yes | Ramp Cross Slope RT (%) | 0.7 |

**Remove & Replace Curb Ramp With Two New Directional Ramps or Equivalent.**

**R304.3.2, R304.5.3, STD 1115**

Total Cost: \$ 4000

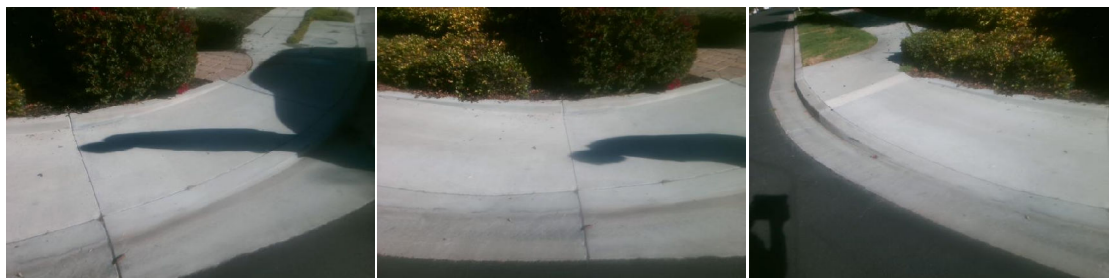
| Compliance | Description | Data | Compliance | Description | Data |
|---|---|---|---|---|---|
| N/A | Ramp Length LT (in) | 123 | N/A | Ramp Length RT (in) | 139 |
| Yes | Ramp Width LT (in) | 52 | Yes | Ramp Width RT (in) | 52 |
