# Access Compliance Report Public Rights-of-Way (Curb Ramps)

Main Street: FALLOW\_LN Cross Street: FOLLATE\_WAY Location: SE

ADA ID: RPRK211028124804 Ramp Type: Type 4 - Parallel Initial Pass/Fail: Pass Overall Compliance: No Severity Score: 25

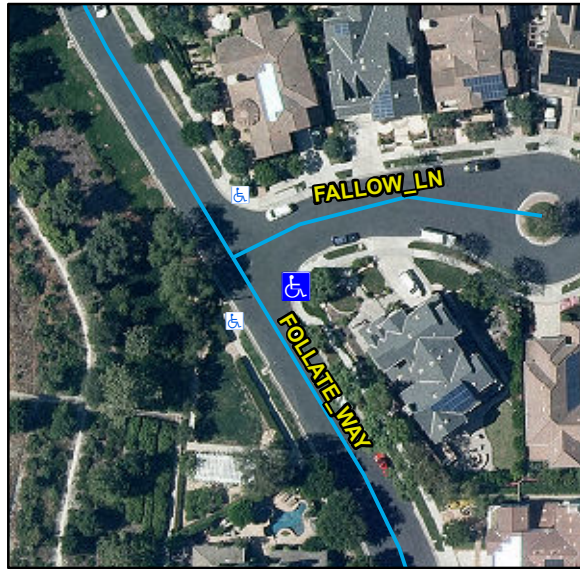
| Compliance | Description | Data | Compliance | Description | Data |
|---|---|---|---|---|---|
| N/A | Landing Present | No | No | DWS Provided | No |
| No | Landing Width (in) | N/A | N/A | DWS Length (in) | N/A |
| No | Landing Run Slope (%) | N/A | N/A | DWS Full Width | N/A |
| No | Landing Cross Slope (%) | N/A | | DWS Offset Type | N/A |
| Yes | Gutter Ponding | No | No | Curb Slope | 9.7 |
| No | Gutter Run Slope (%) | 12.1 | | Road Cross Slope (%) | 2.1 |
| No | Gutter Cross Slope (%) | 4.8 | No | Perpendicular Joint Present | No |

Remove & Replace Curb Ramp With Two New Directional Ramps or Equivalent. Remove & Replace Gutter.
