# Access Compliance Report Public Rights-of-Way (Curb Ramps)

| Main Street: FOLLATE_WAY | | Cross Street: AURA_LN | | Location: | NE |
| ADA ID: RPRK211028125246 | Ramp Type: Type 4 - Parallel | Initial Pass/Fail: Fail | Overall Compliance: No | Severity Score: | 30 |

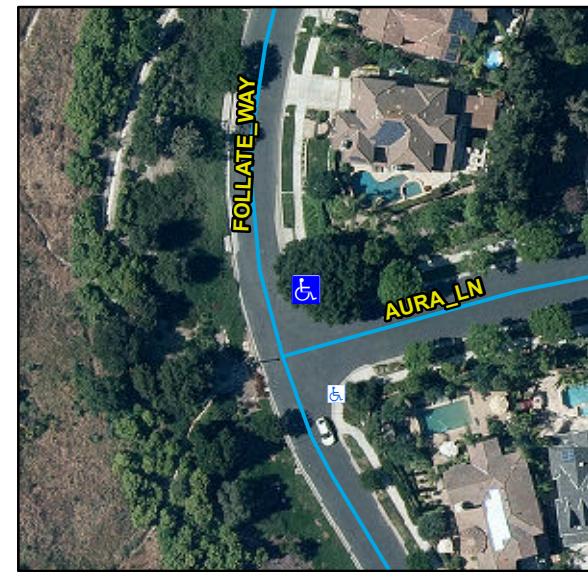
**R204.3, R304.3.2, STD 1115**

| Compliance | Description | Data | Compliance | Description | Data |
|---|---|---|---|---|---|
| No | Ramp Run Slope LT (%) | 13.1 | Yes | Ramp Run Slope RT (%) | 3.6 |

**Remove & Replace Curb Ramp With Two New Directional Ramps or Equivalent.**

Total Cost: \$ 4000
