# Access Compliance Report Public Rights-of-Way (Curb Ramps)

Main Street: GAIA\_LN Cross Street: NARROW\_CANYON\_RD Location: SE

ADA ID: RPRK211028130559 Ramp Type: Type 4 - Parallel Initial Pass/Fail: Fail Overall Compliance: No Severity Score: 16

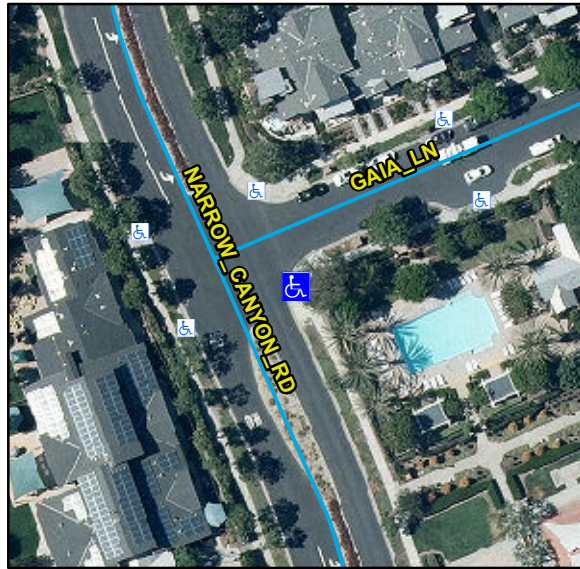
| Compliance | Description | Data | Compliance | Description | Data |
|---|---|---|---|---|---|
| No | Ramp Run Slope LT (%) | 8.5 | Yes | Ramp Run Slope RT (%) | 4.2 |
| No | Ramp Cross Slope LT (%) | 2.3 | Yes | Ramp Cross Slope RT (%) | 2 |

Remove & Replace Curb Ramp With Two New Directional Ramps or Equivalent.

R204.3, R304.3.2, R304.5.3, STD 1115
