# Access Compliance Report Public Rights-of-Way (Curb Ramps)

Main Street: NARROW\_CANYON\_RD Cross Street: GAIA\_LN Location: NE

ADA ID: RPRK211028130802 Ramp Type: Type 4 - Parallel Initial Pass/Fail: Fail Overall Compliance: No Severity Score: 16

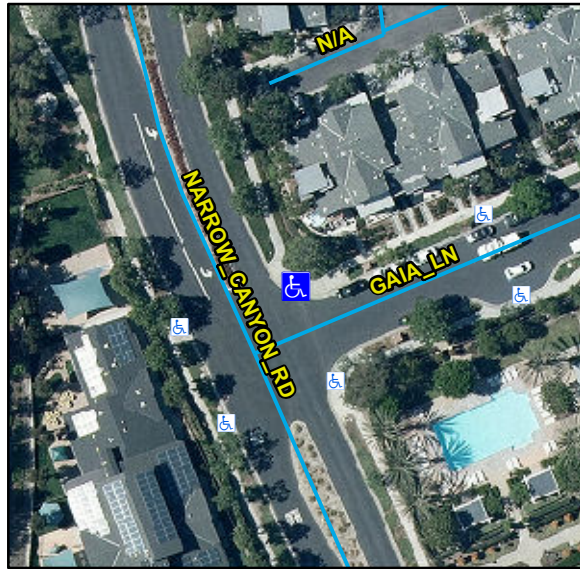
| Compliance | Description | Data | Compliance | Description | Data |
|---|---|---|---|---|---|
| No | Ramp Run Slope LT (%) | 9.1 | Yes | Ramp Run Slope RT (%) | 5.6 |
| No | Ramp Cross Slope LT (%) | 3.4 | Yes | Ramp Cross Slope RT (%) | 1.8 |

Remove & Replace Curb Ramp With Two New Directional Ramps or Equivalent.

R204.3, R304.3.2, R304.5.3, STD 1115
