# Access Compliance Report Public Rights-of-Way (Curb Ramps)

Main Street: N/A Cross Street: NARROW\_CANYON\_RD Location: S

ADA ID: RPRK211028131033 Ramp Type: Type 4 - Parallel Initial Pass/Fail: Pass Overall Compliance: No Severity Score: 26

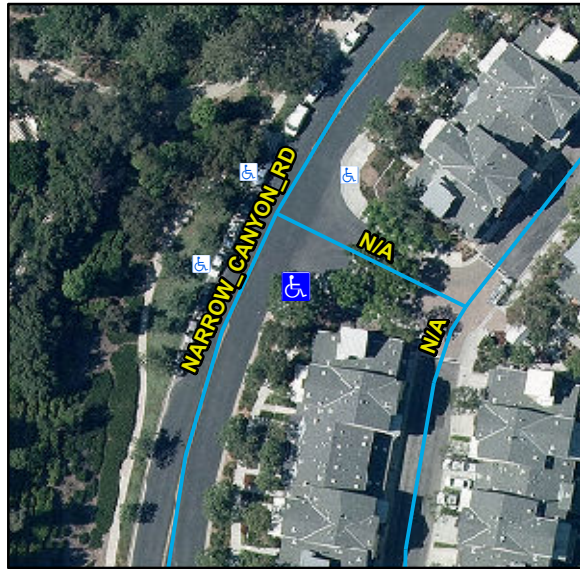
| Compliance | Description | Data | Compliance | Description | Data |
|---|---|---|---|---|---|
| No | Ramp Cross Slope LT (%) | 2.5 | No | Ramp Cross Slope RT (%) | 2.9 |
| No | Gutter Run Slope (%) | 10.2 | | Road Cross Slope (%) | 3.2 |
| No | Gutter Cross Slope (%) | 4 | No | Perpendicular Joint Present | No |

Remove & Replace Curb Ramp With Two New Directional Ramps or Equivalent. Remove & Replace Gutter.
