ADA ID: RPRK211028131519

Access Compliance Report Public Rights-of-Way (Curb Ramps)

Main Street:
 NARROW_CANYON_RD
 Cross Street:
 N/A
 Location:
 SE

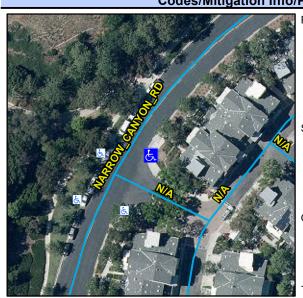
Ramp Type: Type 4 - Parallel

Field Measurements/Component Compliance								
	Compliance Description		Data	Com	pliance	Description	Data	
	N/A	Ramp Length LT (in)	139	N/A	Ramp Le	ength RT (in)	146	
	Yes	Ramp Width LT (in)	90	Yes	Ramp W	idth RT (in)	90	
	Yes	Ramp Run Slope LT (%)	7.7	Yes	Ramp R	un Slope RT (%)	3.2	
	Yes	Ramp Cross Slope LT (%)	1	No	Ramp C	ross Slope RT (%)	2.5	
	N/A	Landing Present	No	No	DWS Pr	ovided	No	
	N/A	Landing Length (in)	N/A	N/A	DWS Co	ontrast	N/A	
	No	Landing Width (in)	N/A	N/A	DWS Le	ngth (in)	N/A	
	No	Landing Run Slope (%)	N/A	N/A	DWS Fu	ll Width	N/A	
	No	Landing Cross Slope (%)	N/A		DWS Of	fset Type	N/A	
	N/A	Landing Movement Obstructed?	No	N/A	DWS Of	fset Left (in)	N/A	
		Landing Movement Type	Curb	N/A	DWS Of	fset Right (in)	N/A	
	N/A	Landing Shared	N/A					
	N/A	Clear Space	Yes					
	N/A	Clear Space To Crosswalk (in)	48					
2	N/A	Marked Crosswalk 1	No	N/A	Marked	Crosswalk 2	No	
		Crossing 1 Direction	N		Crossing	2 Direction	SW

D		Marked Crosswalk 1 Width (in)	N/A		Marked	Crosswalk 2 Width (in)	N/A	
l	N/A	Ramp Inside Crosswalk 1	N/A	N/A	Ramp In	side Crosswalk 2	N/A	
A		Crossing 1 Slope (%)	3.8		Crossing	g 2 Slope (%)	2.9	
l		Crossing 1 Cross Slope (%)	2.6		Crossing	g 2 Cross Slope (%)	2.5	
	Yes	Gutter Ponding	No	No	Curb Slo	ppe	9.3	
	Yes	Gutter Lip Height (in)	0		Road Ru	ın Slope (%)	3.1	
_	No	Gutter Run Slope (%)	11.2		Road Cr	oss Slope (%)	0.3	
<u>a</u>	Yes	Gutter Cross Slope (%)	2.2	No	Perpend	icular Joint Present	No	
0	Yes	Overall Surface Condition Accep	ptable					
		Cross Gutter Present?	No		Spandre	el Present?	No	
A		Replace Cross Gutter?	N/A		Replace	Spandrel?	N/A

Overall Compliance: No

Remove & Replace Curb Ramp With Two New
Directional Ramps or Equivalent. Remove &
Replace Gutter.
