# Access Compliance Report Public Rights-of-Way (Curb Ramps)

| Main Street: NARROW_CANYON_RD | | Cross Street: N/A | | Location: | N |
| ADA ID: RPRK211028131759 | Ramp Type:Type 1 - Perpendicular | Initial Pass/Fail: Pass | Overall Compliance: No | Severity Score: | 17 |

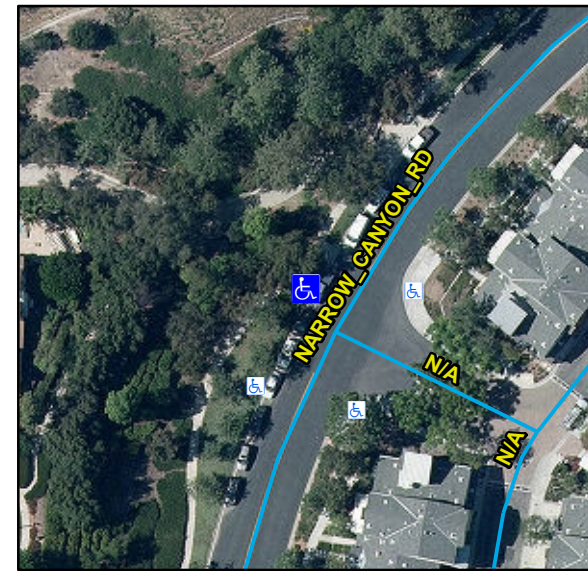
| Compliance | Description | Data | Compliance | Description | Data |
|---|---|---|---|---|---|
| No | Landing Run Slope (%) | 3.1 | N/A | Flare Traversable RT | No |
| No | Landing Cross Slope (%) | 2.3 | No | DWS Provided | No |
| Yes | Gutter Ponding | No | No | Curb Slope | 12 |
| No | Gutter Run Slope (%) | 12.3 | | Road Cross Slope (%) | N/A |
| No | Gutter Cross Slope (%) | 2.1 | | | |

**Remove & Replace Entire Ramp. Remove & Replace Gutter.**
