# Access Compliance Report Public Rights-of-Way (Curb Ramps)

| Main Street: NARROW_CANYON_RD | | Cross Street: GAIA_LN | | Location: | NW |
| ADA ID: RPRK211028132112 | Ramp Type: Type 1 - Perpendicular | Initial Pass/Fail: Fail | Overall Compliance: No | Severity Score: | 2 |

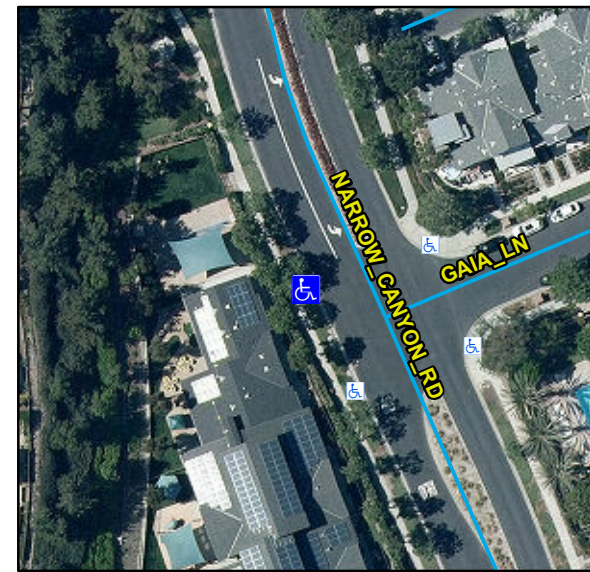
| Compliance | Description | Data | Compliance | Description | Data |
|---|---|---|---|---|---|
| No | Ramp Cross Slope (%) | 2.5 | N/A | Flare Traversable LT | N/A |
| N/A | Gutter Ponding | N/A | No | Curb Slope | 7.3 |

Possible Solutions:

Remove & Replace Entire Ramp.
