# Access Compliance Report Public Rights-of-Way (Curb Ramps)

Main Street: SNOW\_BUSH\_ST Cross Street: GREVILLEA\_CT Location: E

ADA ID: RPRK211028133143 Ramp Type: Type 4 - Parallel Initial Pass/Fail: Pass Overall Compliance: No Severity Score: 25

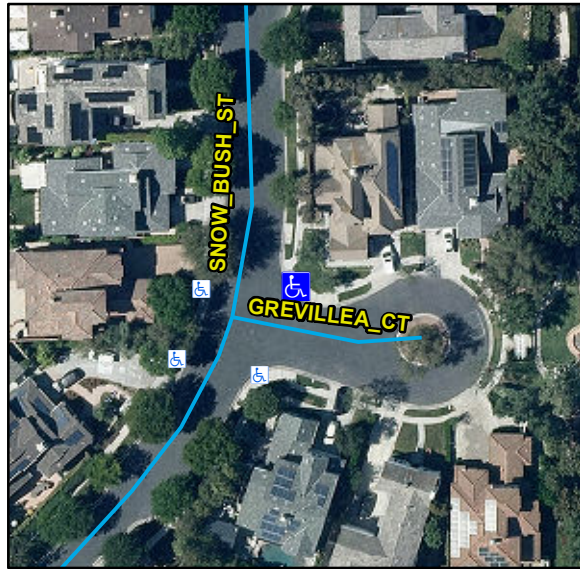
| Compliance | Description | Data | Compliance | Description | Data |
|---|---|---|---|---|---|
| N/A | Landing Present | No | No | DWS Provided | No |
| No | Landing Width (in) | N/A | N/A | DWS Length (in) | N/A |
| No | Landing Run Slope (%) | N/A | N/A | DWS Full Width | N/A |
| No | Landing Cross Slope (%) | N/A | | DWS Offset Type | N/A |
| No | Gutter Run Slope (%) | 9.9 | | Road Cross Slope (%) | 1.2 |

Remove & Replace Curb Ramp With Two New Directional Ramps or Equivalent. Remove & Replace Gutter.
