# Access Compliance Report Public Rights-of-Way (Curb Ramps)

Main Street: GREVILLEA\_CT Cross Street: SNOW\_BUSH\_ST Location: S

ADA ID: RPRK211028133437 Ramp Type: Type 4 - Parallel Initial Pass/Fail: Pass Overall Compliance: No Severity Score: 25

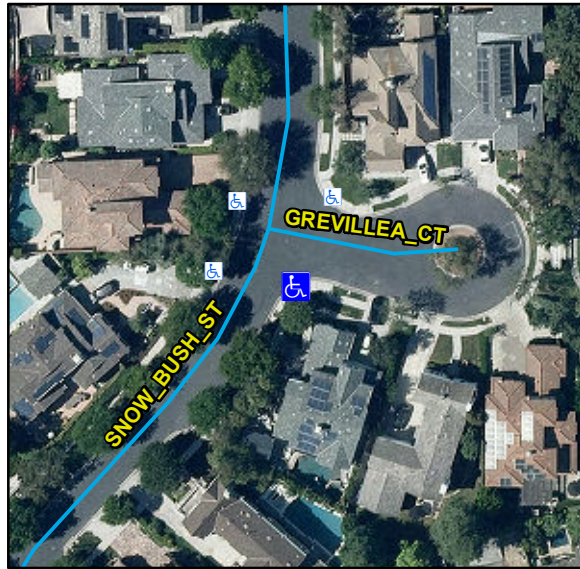
| Compliance | Description | Data | Compliance | Description | Data |
|---|---|---|---|---|---|
| N/A | Landing Present | No | No | DWS Provided | No |
| No | Landing Width (in) | N/A | N/A | DWS Length (in) | N/A |
| No | Landing Run Slope (%) | N/A | N/A | DWS Full Width | N/A |
| No | Landing Cross Slope (%) | N/A | | DWS Offset Type | N/A |
| No | Gutter Run Slope (%) | 6.1 | | Road Cross Slope (%) | 2.4 |

Remove & Replace Curb Ramp With Two New Directional Ramps or Equivalent. Remove & Replace Gutter.
