# Access Compliance Report Public Rights-of-Way (Curb Ramps)

Main Street: SNOW\_BUSH\_ST Cross Street: GARDENIA\_ST Location: NE

ADA ID: RPRK211028133651 Ramp Type: Type 4 - Parallel Initial Pass/Fail: Pass Overall Compliance: No Severity Score: 25

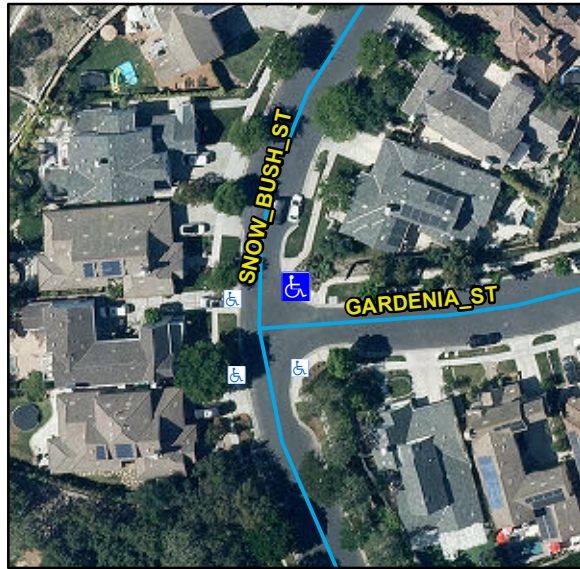
| Compliance | Description | Data | Compliance | Description | Data |
|---|---|---|---|---|---|
| N/A | Landing Present | No | No | DWS Provided | No |
| No | Landing Width (in) | N/A | N/A | DWS Length (in) | N/A |
| No | Landing Run Slope (%) | N/A | N/A | DWS Full Width | N/A |
| No | Landing Cross Slope (%) | N/A | | DWS Offset Type | N/A |
| Yes | Gutter Ponding | No | No | Curb Slope | 8.7 |
| No | Gutter Run Slope (%) | 9.4 | | Road Cross Slope (%) | 1.9 |

Remove & Replace Curb Ramp With Two New Directional Ramps or Equivalent. Remove & Replace Gutter.
