# Access Compliance Report Public Rights-of-Way (Curb Ramps)

Main Street: GARDENIA\_ST Cross Street: SNOW\_BUSH\_ST Location: SE

ADA ID: RPRK211028134045 Ramp Type: Type 4 - Parallel Initial Pass/Fail: Pass Overall Compliance: No Severity Score: 25

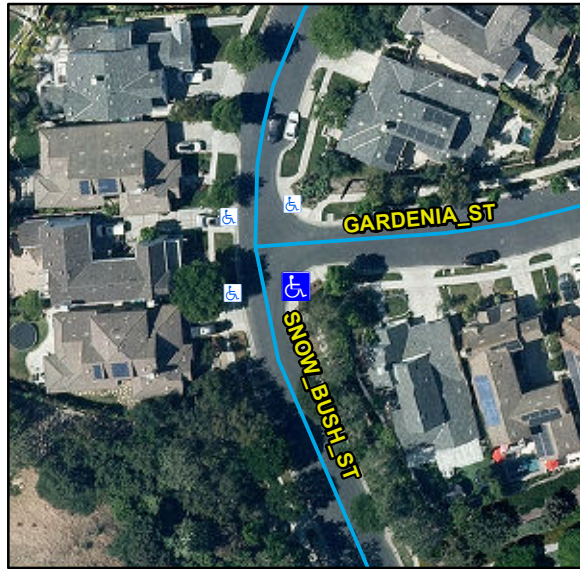
| Compliance | Description | Data | Compliance | Description | Data |
|---|---|---|---|---|---|
| N/A | Landing Present | No | No | DWS Provided | No |
| No | Landing Width (in) | N/A | N/A | DWS Length (in) | N/A |
| No | Landing Run Slope (%) | N/A | N/A | DWS Full Width | N/A |
| No | Landing Cross Slope (%) | N/A | | DWS Offset Type | N/A |
| No | Gutter Ponding | Yes | No | Curb Slope | 9.7 |
| No | Gutter Run Slope (%) | 13.5 | | Road Cross Slope (%) | 2 |
| No | Gutter Cross Slope (%) | 4.6 | No | Perpendicular Joint Present | No |

Remove & Replace Curb Ramp With Two New Directional Ramps or Equivalent. Remove & Replace Gutter.
