# Access Compliance Report Public Rights-of-Way (Curb Ramps)

Main Street: SNOW\_BUSH\_ST Cross Street: CLARIN\_ST Location: NE

ADA ID: RPRK211028134258 Ramp Type: Type 4 - Parallel Initial Pass/Fail: Fail Overall Compliance: No Severity Score: 16

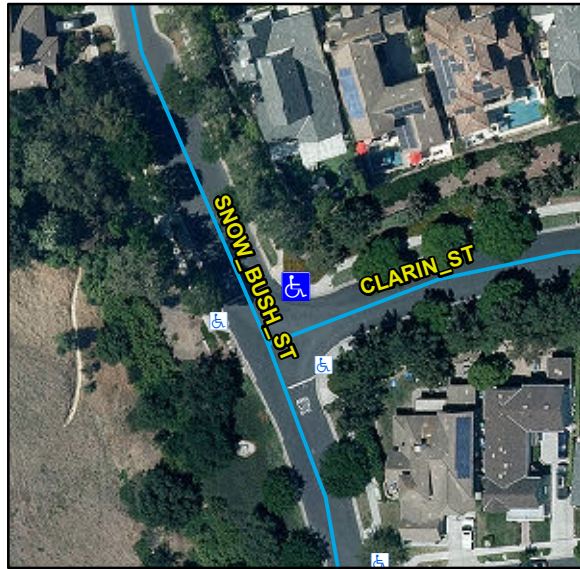
| Compliance | Description | Data | Compliance | Description | Data |
|---|---|---|---|---|---|
| No | Ramp Run Slope LT (%) | 10.2 | Yes | Ramp Run Slope RT (%) | 0.9 |
| No | Ramp Cross Slope LT (%) | 2.3 | No | Ramp Cross Slope RT (%) | 4 |

**Remove & Replace Curb Ramp With Two New Directional Ramps or Equivalent.**
