# Access Compliance Report Public Rights-of-Way (Curb Ramps)

**Main Street:** SNOW\_BUSH\_ST      **Cross Street:** CLARIN\_ST      **Location:** NW

**ADA ID:** RPRK211028134507      **Ramp Type:** Type 1 - Perpendicular      **Initial Pass/Fail:** Fail      **Overall Compliance:** No      **Severity Score:** 16

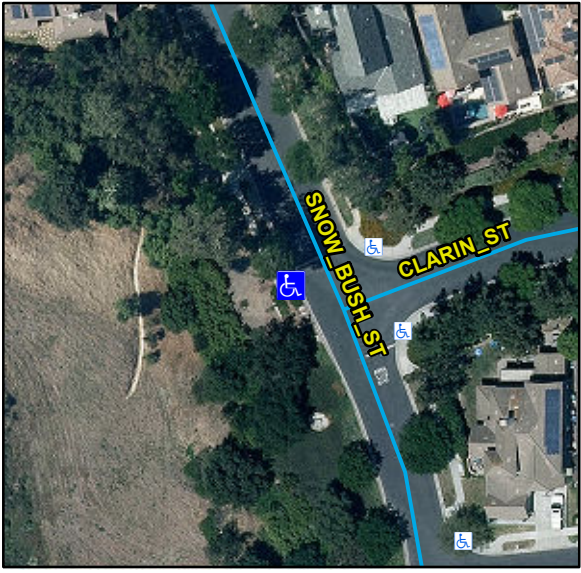
Compliance	Description	Data	Compliance	Description	Data
N/A	Ramp Length (in)	65	N/A	Flare Type LT	
Yes	Ramp Width (in)	48			N/A
No	Ramp Run Slope (%)	9.5	N/A	Flare Slope LT (%)	N/A
No	Ramp Cross Slope (%)	4.2	N/A	Flare Traversable LT	N/A
N/A	Landing Present	N/A	N/A	Flare Type RT	
N/A	Landing Length (in)	N/A			N/A
N/A	Landing Width (in)	N/A	N/A	Flare Slope RT (%)	N/A
N/A	Landing Run Slope (%)	N/A	N/A	Flare Traversable RT	N/A
N/A	Landing Cross Slope (%)	N/A	N/A	DWS Provided	N/A
N/A	Landing Movement Obstructed?	N/A	N/A	DWS Contrast	N/A
	Landing Movement Type	N/A	N/A	DWS Length (in)	N/A
N/A	Landing Shared	N/A	N/A	DWS Full Width	N/A
N/A	Clear Space	N/A	N/A	DWS Offset Left (in)	N/A
N/A	Clear Space To Crosswalk (in)	N/A	N/A	DWS Offset Right (in)	N/A
N/A	Marked Crosswalk 1	No	N/A	Marked Crosswalk 2	N/A
	Crossing 1 Direction	E		Crossing 2 Direction	N/A
	Marked Crosswalk 1 Width (in)	N/A		Marked Crosswalk 2 Width (in)	N/A

N/A	Ramp Inside Crosswalk 1	N/A	Yes	Ramp Inside Crosswalk 2	N/A
	Crossing 1 Slope (%)	2.8		Crossing 2 Slope (%)	N/A
	Crossing 1 Cross Slope (%)	4.5		Crossing 2 Cross Slope (%)	N/A
N/A	Gutter Ponding	N/A	No	Curb Slope	8.2
Yes	Gutter Lip Height (in)	0		Road Run Slope (%)	N/A
N/A	Gutter Run Slope (%)	N/A		Road Cross Slope (%)	N/A
N/A	Gutter Cross Slope (%)	N/A			
Yes	Overall Surface Condition:	Acceptable	No	Perp Joint Present	No
	Cross Gutter Present?	No		Spandrel Present?	No
	Replace Cross Gutter?	N/A		Replace Spandrel?	N/A

**Possible Solutions:**  
Remove & Replace Entire Ramp.
