# Access Compliance Report Public Rights-of-Way (Curb Ramps)

Main Street: CLARIN\_ST Cross Street: SNOW\_BUSH\_ST Location: SE

ADA ID: RPRK211028134612 Ramp Type: Type 4 - Parallel Initial Pass/Fail: Fail Overall Compliance: No Severity Score: 2

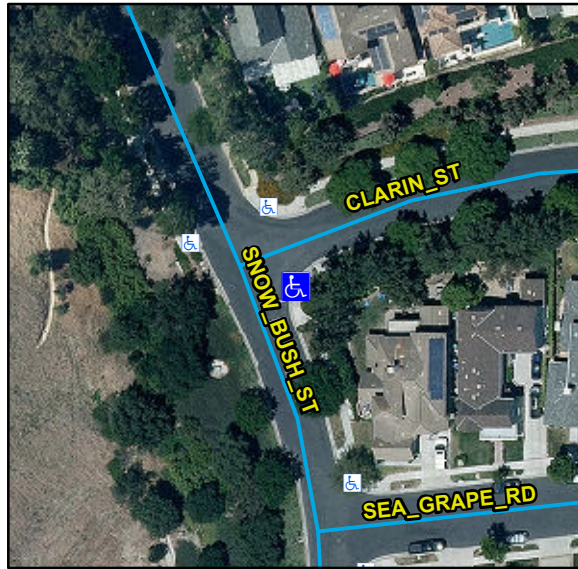
| Compliance | Description | Data | Compliance | Description | Data |
|---|---|---|---|---|---|
| Yes | Ramp Cross Slope LT (%) | 1.2 | No | Ramp Cross Slope RT (%) | 2.7 |

Remove & Replace Curb Ramp With Two New Directional Ramps or Equivalent.

R204.3, R304.5.3, STD 1115
