# Access Compliance Report Public Rights-of-Way (Curb Ramps)

Main Street: SNOW\_BUSH\_ST Cross Street: SEA\_GRAPE\_RD Location: NE

ADA ID: RPRK211028134836 Ramp Type: Type 4 - Parallel Initial Pass/Fail: Pass Overall Compliance: No Severity Score: 20

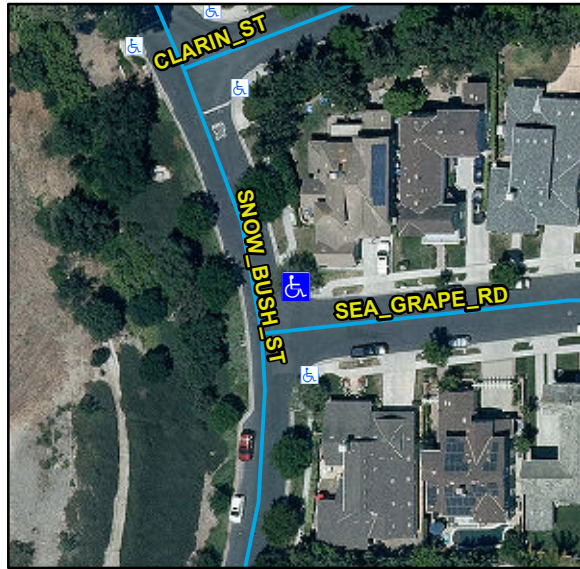
| Compliance | Description | Data | Compliance | Description | Data |
|---|---|---|---|---|---|
| N/A | Landing Present | No | No | DWS Provided | No |
| No | Landing Width (in) | N/A | N/A | DWS Length (in) | N/A |
| No | Landing Run Slope (%) | N/A | N/A | DWS Full Width | N/A |
| No | Landing Cross Slope (%) | N/A | | DWS Offset Type | N/A |
| Yes | Gutter Ponding | No | No | Curb Slope | 12.7 |
| No | Gutter Cross Slope (%) | 5 | No | Perpendicular Joint Present | No |

Remove & Replace Curb Ramp With Two New Directional Ramps or Equivalent. Remove & Replace Gutter.
