# Access Compliance Report Public Rights-of-Way (Curb Ramps)

| Main Street: SEA_GRAPE_RD | Cross Street: SNOW_BUSH_ST | Location: SE |

| ADA ID: RPRK211028135042 | Ramp Type: Type 4 - Parallel | Initial Pass/Fail: Pass | Overall Compliance: No | Severity Score: 25 |

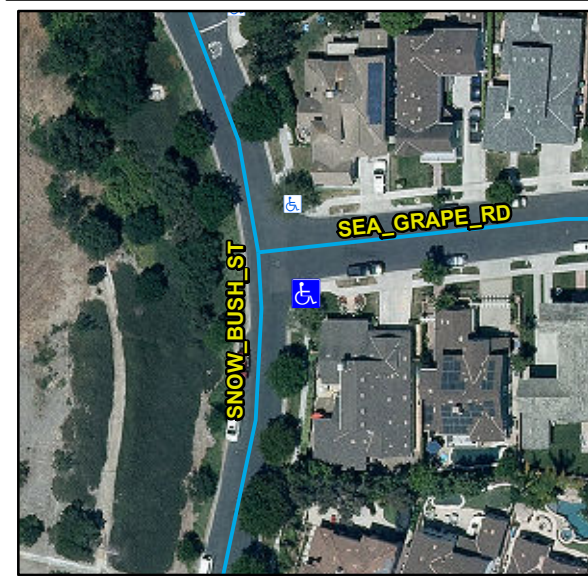
| Compliance | Description | Data | Compliance | Description | Data |
|---|---|---|---|---|---|
| Yes | Ramp Run Slope LT (%) | 5.3 | Yes | Ramp Run Slope RT (%) | 6.2 |
| N/A | Landing Present | No | No | DWS Provided | No |
| No | Landing Width (in) | N/A | N/A | DWS Length (in) | N/A |
| No | Landing Run Slope (%) | N/A | N/A | DWS Full Width | N/A |
| No | Landing Cross Slope (%) | N/A | | DWS Offset Type | N/A |
| No | Gutter Run Slope (%) | 8.8 | | Road Cross Slope (%) | 3.9 |

**Remove & Replace Curb Ramp With Two New Directional Ramps or Equivalent. Remove & Replace Gutter.**

**R204.3, R304.2.1, R304.2.2-Perp, R304.3.2-Para, R304.5.3, R305, R304.5.4, STD 1115**

Total Cost: \$ 4252

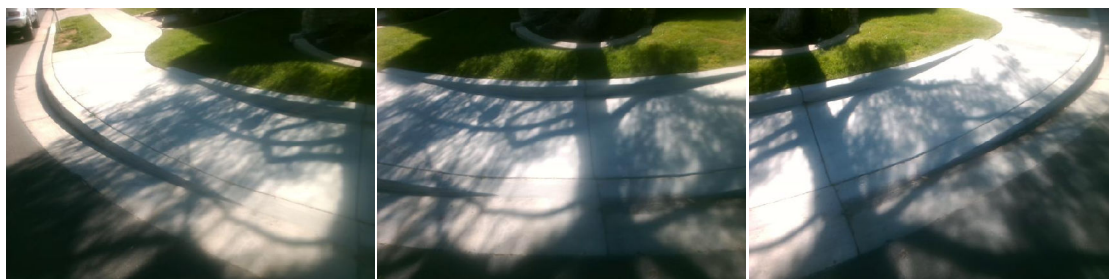
| Compliance | Description | Data | Compliance | Description | Data |
| N/A | Ramp Length LT (in) | 122 | N/A | Ramp Length RT (in) | 132 |
| Yes | Ramp Width LT (in) | 53 | Yes | Ramp Width RT (in) | 54 |

Possible Solutions:
