# Access Compliance Report Public Rights-of-Way (Curb Ramps)

| Main Street: SNOW_BUSH_ST | | Cross Street: CALLIANDRA_ST | | Location: | E |
| ADA ID: RPRK211028135329 | Ramp Type: Type 4 - Parallel | Initial Pass/Fail: Fail | Overall Compliance: No | Severity Score: | 2 |

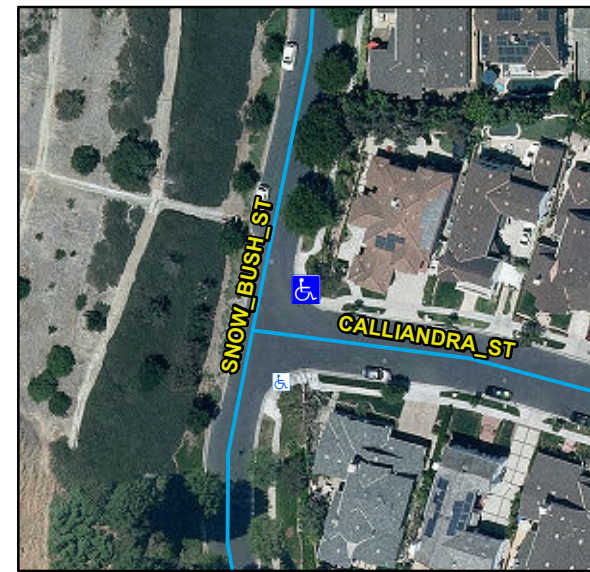
| Compliance | Description | Data | Compliance | Description | Data |
|---|---|---|---|---|---|
| No | Ramp Cross Slope LT (%) | 2.8 | No | Ramp Cross Slope RT (%) | 2.7 |

**Remove & Replace Curb Ramp With Two New Directional Ramps or Equivalent.**

**R204.3, R304.5.3, STD 1115**

Total Cost: \$ 4000

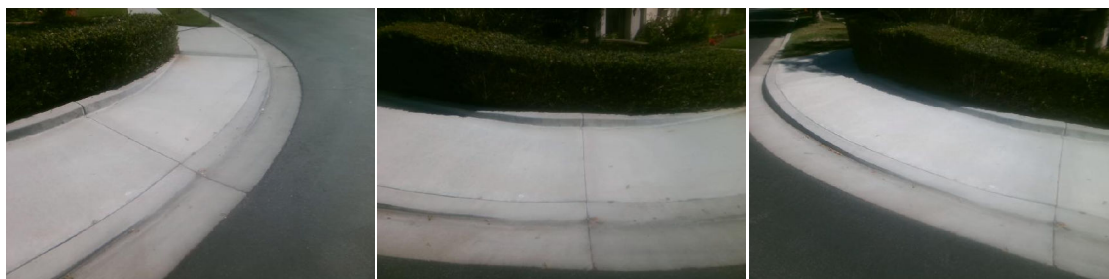
| Compliance | Description | Data | Compliance | Description | Data |
|---|---|---|---|---|---|
| N/A | Ramp Length LT (in) | 166 | N/A | Ramp Length RT (in) | 130 |
| Yes | Ramp Width LT (in) | 53 | Yes | Ramp Width RT (in) | 53 |
| Yes | Ramp Run Slope LT (%) | 7.2 | Yes | Ramp Run Slope RT (%) | 2.6 |
