# Access Compliance Report Public Rights-of-Way (Curb Ramps)

Main Street: CALLIANDRA\_ST Cross Street: SNOW\_BUSH\_ST Location: S

ADA ID: RPRK211028135541 Ramp Type: Type 4 - Parallel Initial Pass/Fail: Pass Overall Compliance: No Severity Score: 25

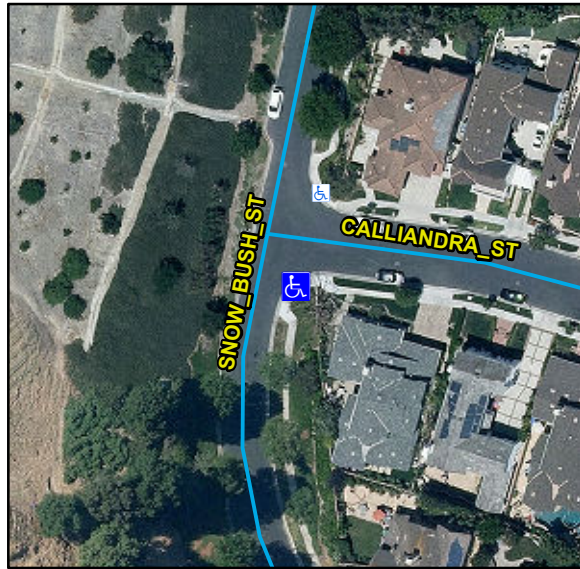
## Field Measurements/Component Compliance

**Remove & Replace Curb Ramp With Two New Directional Ramps or Equivalent. Remove & Replace Gutter.**

**R304.2.2, R204.3, R304.2.1, R304.2.2-Perp, R304.3.2-Para, R304.5.3, R305, R304.5.4, STD 1115**
