# Access Compliance Report Public Rights-of-Way (Curb Ramps)

Main Street: CLARIN\_ST Cross Street: NARROW\_CANYON\_RD Location: W

ADA ID: RPRK211028140341 Ramp Type: Type 1 - Perpendicular Initial Pass/Fail: Pass Overall Compliance: No Severity Score: 16

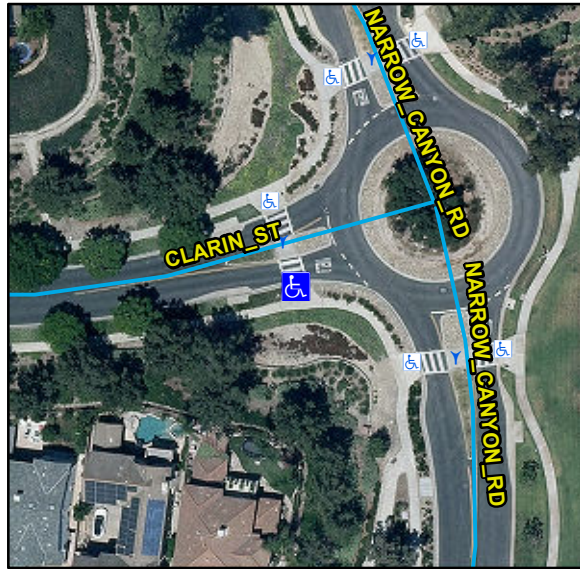
| Compliance | Description | Data | Compliance | Description | Data |
|---|---|---|---|---|---|
| No | Landing Run Slope (%) | 2.3 | N/A | Flare Traversable RT | No |
| No | Landing Cross Slope (%) | 3.1 | No | DWS Provided | No |
| No | Gutter Run Slope (%) | 12.9 | | Road Cross Slope (%) | N/A |
| No | Gutter Cross Slope (%) | 3.1 | | | |

Remove & Replace Entire Ramp. Remove & Replace Gutter.
