# Access Compliance Report Public Rights-of-Way (Curb Ramps)

Main Street: NARROW\_CANYON\_RD Cross Street: CLARIN\_ST Location: S

ADA ID: RPRK211028140622 Ramp Type: Type 1 - Perpendicular Initial Pass/Fail: Fail Overall Compliance: No Severity Score: 0

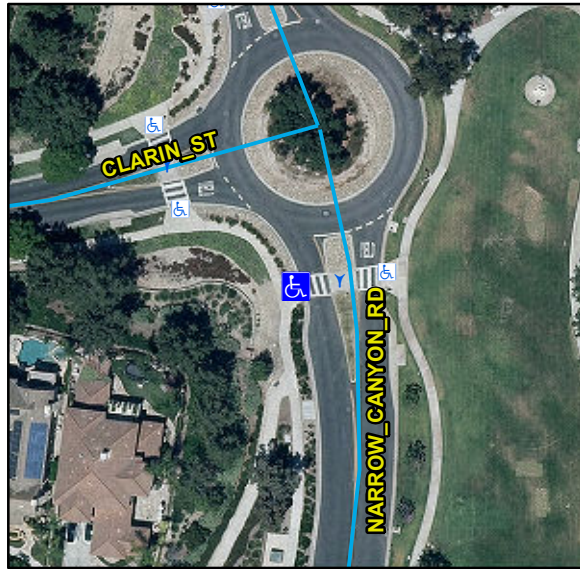
| Compliance | Description | Data | Compliance | Description | Data |
|---|---|---|---|---|---|
| N/A | Ramp Length (in) | 92 | N/A | Flare Type LT | |
| Yes | Ramp Width (in) | 48 | | | N/A |
| Yes | Ramp Run Slope (%) | 7.6 | N/A | Flare Slope LT (%) | N/A |
| Yes | Ramp Cross Slope (%) | 2.9 | N/A | Flare Traversable LT | N/A |

Possible Solutions:

Remove & Replace Entire Ramp.

R204.3, STD 1115
