# Access Compliance Report Public Rights-of-Way (Curb Ramps)

| Main Street: NARROW_CANYON_RD | | Cross Street: CLARIN_ST | | Location: | S |
| ADA ID: RPRK211028140750 | Ramp Type:Type 1 - Perpendicular | Initial Pass/Fail: Fail | Overall Compliance: No | Severity Score: | 16 |

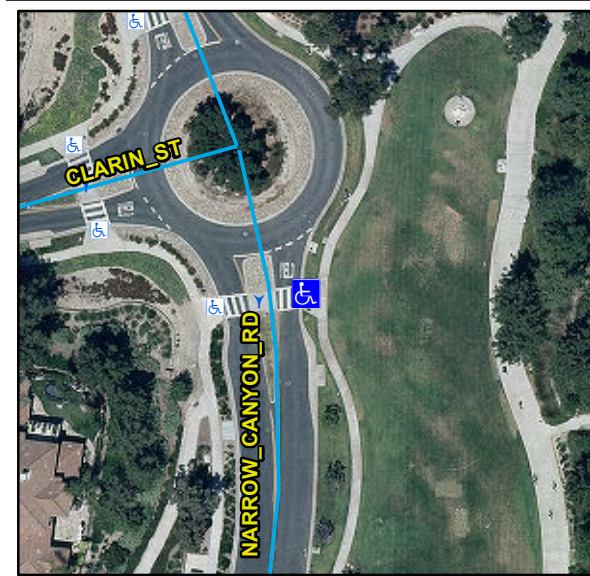
**R304.2.2, R204.3, R304.5.3, STD 1115**

| Compliance | Description | Data | Compliance | Description | Data |
|---|---|---|---|---|---|
| No | Ramp Run Slope (%) | 9.1 | N/A | Flare Slope LT (%) | N/A |
| No | Ramp Cross Slope (%) | 4 | N/A | Flare Traversable LT | N/A |

**Remove & Replace Entire Ramp.**

Total Cost: \$ 3080

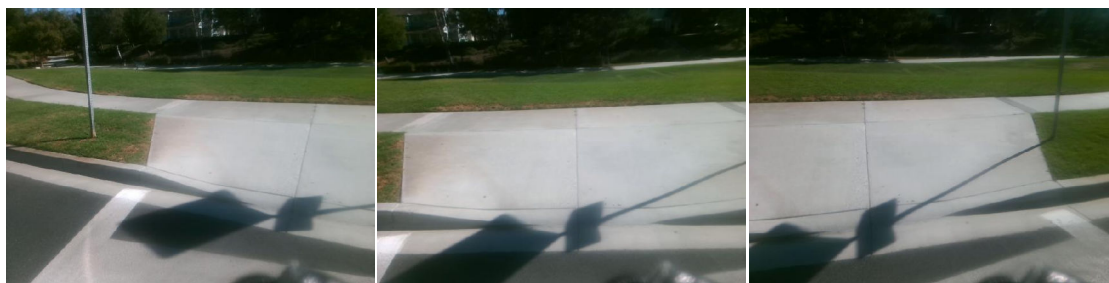
| Compliance | Description | Data | Compliance | Description | Data |
|---|---|---|---|---|---|
| N/A | Ramp Length (in) | 92 | N/A | Flare Type LT | |
| Yes | Ramp Width (in) | 48 | | | N/A |
| N/A | Gutter Ponding | N/A | No | Curb Slope | 21.3 |
