# Access Compliance Report Public Rights-of-Way (Curb Ramps)

| Main Street: NARROW_CANYON_RD | | Cross Street: CLARIN_ST | | Location: | N |
| ADA ID: RPRK211028140921 | Ramp Type:Type 1 - Perpendicular | Initial Pass/Fail: Fail | Overall Compliance: No | Severity Score: | 2 |

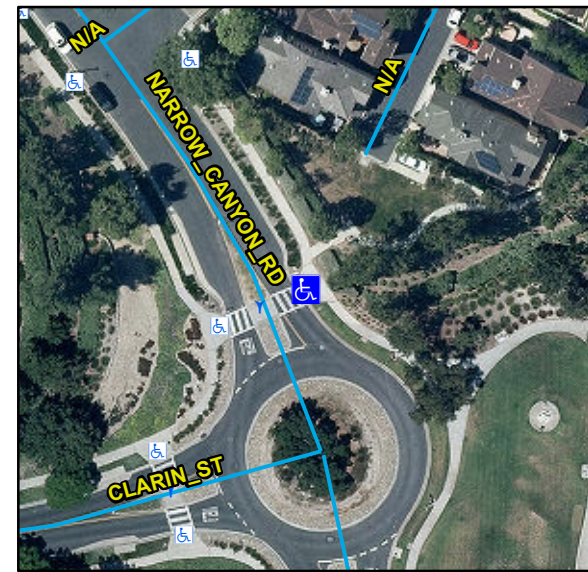
| Compliance | Description | Data | Compliance | Description | Data |
|---|---|---|---|---|---|
| No | Ramp Cross Slope (%) | 3 | N/A | Flare Traversable LT | N/A |
| N/A | Gutter Ponding | N/A | No | Curb Slope | 9.8 |

Possible Solutions:

Remove & Replace Entire Ramp.

R304.2.2, R204.3, R304.5.3, STD 1115

Total Cost: \$ 3080

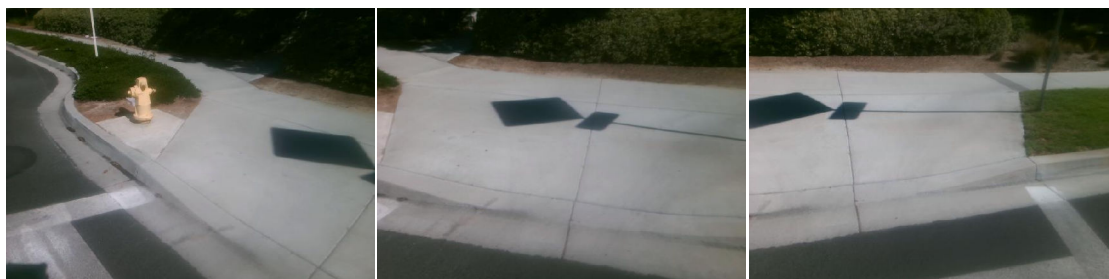
| Compliance | Description | Data | Compliance | Description | Data |
|---|---|---|---|---|---|
| Yes | Ramp Width (in) | 48 | | | N/A |
| Yes | Ramp Run Slope (%) | 8.2 | N/A | Flare Slope LT (%) | N/A |
