# Access Compliance Report Public Rights-of-Way (Curb Ramps)

| Main Street: NARROW_CANYON_RD | | Cross Street: CLARIN_ST | | Location: | N |
| ADA ID: RPRK211028141058 | Ramp Type:Type 1 - Perpendicular | Initial Pass/Fail: Fail | Overall Compliance: No | Severity Score: | 2 |

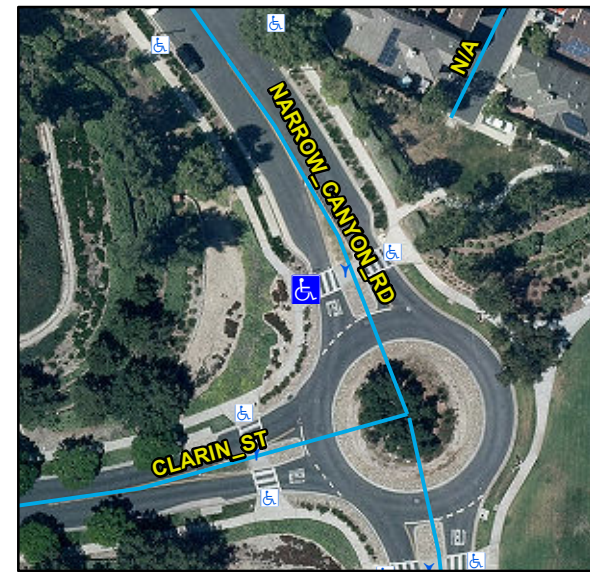
| Compliance | Description | Data | Compliance | Description | Data |
|---|---|---|---|---|---|
| No | Ramp Cross Slope (%) | 3.2 | N/A | Flare Traversable LT | N/A |

Remove & Replace Entire Ramp.

R204.3, R304.5.3, STD 1115

Total Cost: \$ 3080
