# Access Compliance Report Public Rights-of-Way (Curb Ramps)

Main Street: CLARIN\_ST Cross Street: NARROW\_CANYON\_RD Location: W

ADA ID: RPRK211028141324 Ramp Type: Type 1 - Perpendicular Initial Pass/Fail: Fail Overall Compliance: No Severity Score: 0

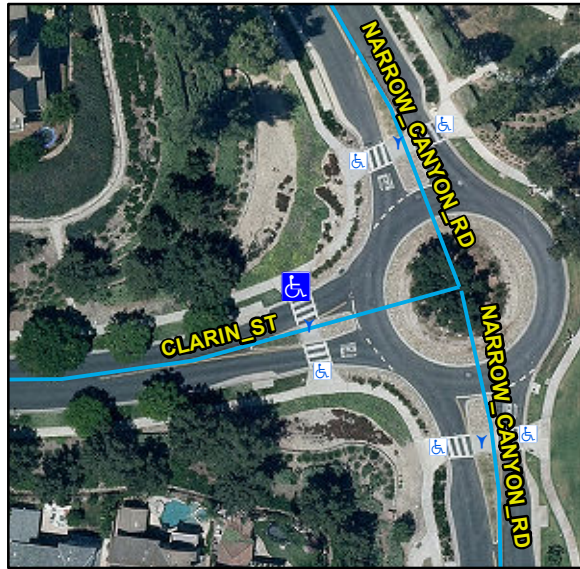
| Compliance | Description | Data | Compliance | Description | Data |
|---|---|---|---|---|---|
| N/A | Gutter Ponding | N/A | No | Curb Slope | 12.1 |

Remove & Replace Entire Ramp.

R304.2.2, R204.3, STD 1115
