# Access Compliance Report Public Rights-of-Way (Curb Ramps)

Main Street: THORNHILL\_ST Cross Street: WYNDHAM\_ST Location: E

ADA ID: RPRK211028160828 Ramp Type: Type 4 - Parallel Initial Pass/Fail: Fail Overall Compliance: No Severity Score: 32

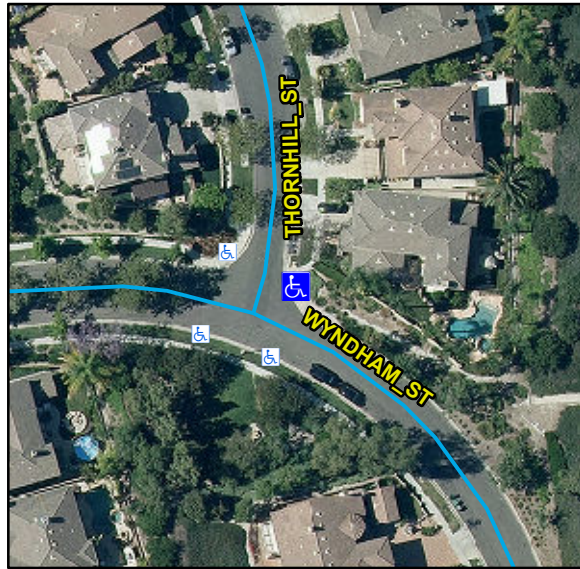
| Compliance | Description | Data | Compliance | Description | Data |
|---|---|---|---|---|---|
| Yes | Ramp Run Slope LT (%) | 3.9 | No | Ramp Run Slope RT (%) | 19.5 |
| No | Ramp Cross Slope LT (%) | 3 | No | Ramp Cross Slope RT (%) | 4.4 |

Remove & Replace Curb Ramp With Two New Directional Ramps or Equivalent.
