# Access Compliance Report Public Rights-of-Way (Curb Ramps)

| Main Street: WYNDHAM_ST | | Cross Street: THORNHILL_ST | | Location: | N |
| ADA ID: RPRK211028161233 | Ramp Type: Type 4 - Parallel | Initial Pass/Fail: Fail | Overall Compliance: No | Severity Score: | 32 |

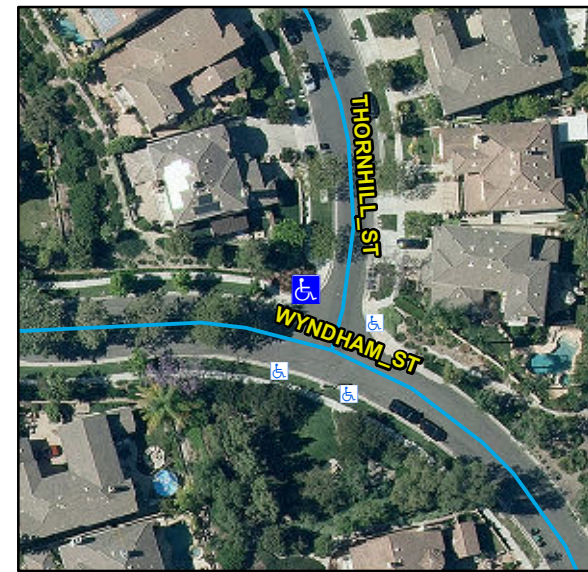
| Compliance | Description | Data | Compliance | Description | Data |
|---|---|---|---|---|---|
| Yes | Ramp Run Slope LT (%) | 3.3 | No | Ramp Run Slope RT (%) | 18 |
| Yes | Ramp Cross Slope LT (%) | 1.9 | No | Ramp Cross Slope RT (%) | 3.4 |

**Remove & Replace Curb Ramp With Two New Directional Ramps or Equivalent.**

**R304.3.2, R304.5.3, STD 1115**
