# Access Compliance Report Public Rights-of-Way (Curb Ramps)

| Main Street: BENJAMIN_DR | | Cross Street: BENJAMIN_DR | | Location: | N |
| ADA ID: RPRK211028162659 | Ramp Type:Type 1 - Perpendicular | Initial Pass/Fail: Fail | Overall Compliance: No | Severity Score: | 45 |

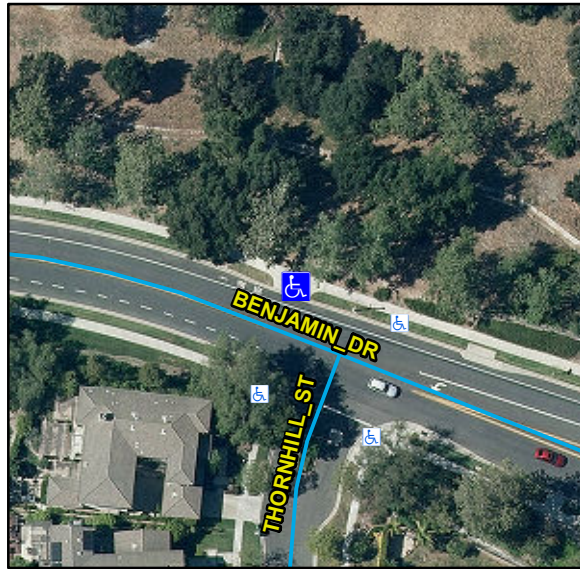
R304.2.2, R204.3, R304.5.3, STD 1115

| Compliance | Description | Data | Compliance | Description | Data |
|---|---|---|---|---|---|
| No | Ramp Run Slope (%) | 9.1 | N/A | Flare Slope LT (%) | N/A |
| No | Ramp Cross Slope (%) | 10.3 | N/A | Flare Traversable LT | N/A |

Remove & Replace Entire Ramp.
