# Access Compliance Report Public Rights-of-Way (Curb Ramps)

Main Street: ANTONIO\_PKWY Cross Street: BENJAMIN\_DR Location: W

ADA ID: RPRK211028164326 Ramp Type: Type 1 - Perpendicular Diagonal Initial Pass/Fail: Fail Overall Compliance: No Severity Score: 30

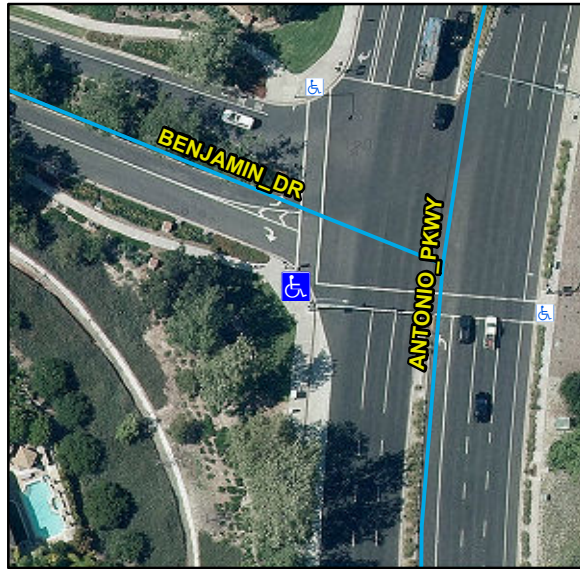
| Compliance | Description | Data | Compliance | Description | Data |
|---|---|---|---|---|---|
| No | Ramp Cross Slope (%) | 8 | N/A | Flare Traversable LT | N/A |
| N/A | Gutter Ponding | N/A | No | Curb Slope | 9.7 |

**Remove & Replace Curb Ramp With Two New Directional Ramps or Equivalent.**

**R304.2.2, R204.3, R304.5.3, STD 1115**
