# Access Compliance Report Public Rights-of-Way (Curb Ramps)

Main Street: BENJAMIN\_DR Cross Street: ANTONIO\_PKWY Location: NW

ADA ID: RPRK211028164919 Ramp Type: Type 1 - Perpendicular Diagonal Initial Pass/Fail: Fail Overall Compliance: No Severity Score: 16

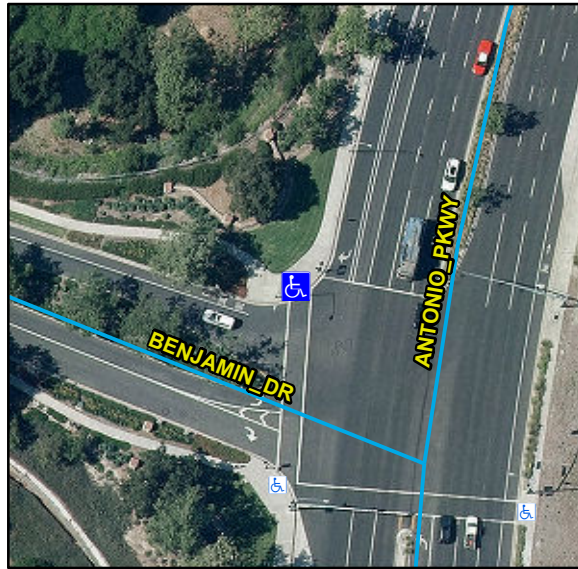
| Compliance | Description | Data | Compliance | Description | Data |
|---|---|---|---|---|---|
| No | Ramp Run Slope (%) | 10.1 | N/A | Flare Slope LT (%) | N/A |
| No | Ramp Cross Slope (%) | 4.3 | N/A | Flare Traversable LT | N/A |

Remove & Replace Curb Ramp With Two New Directional Ramps or Equivalent.

R304.2.2, R204.3, R304.5.3, STD 1115

Total Cost: \$ 6160
