# Access Compliance Report Public Rights-of-Way (Curb Ramps)

Main Street: ANTONIO\_PKWY Cross Street: SWEETWATER Location: W

ADA ID: RPRK211028171327 Ramp Type: Type 1 - Perpendicular Diagonal Initial Pass/Fail: Pass Overall Compliance: No Severity Score: 21

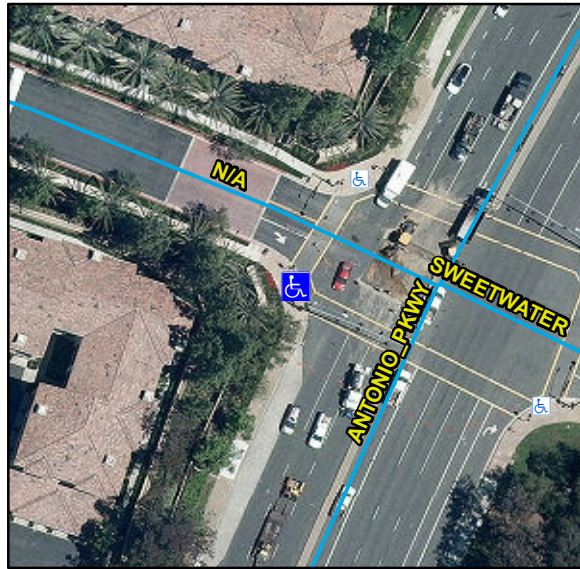
| Compliance | Description | Data | Compliance | Description | Data |
|---|---|---|---|---|---|
| No | Landing Run Slope (%) | 2.6 | N/A | Flare Traversable RT | No |
| Yes | Landing Cross Slope (%) | 1.1 | No | DWS Provided | No |
| No | Gutter Run Slope (%) | 9 | | Road Cross Slope (%) | 0.8 |

Remove & Replace Curb Ramp With Two New Directional Ramps or Equivalent. Remove & Replace Gutter.
