Access Compliance Report Public Rights-of-Way (Curb Ramps)

Main Street: ANTONIO_PKWY Cross Street: SWEETWATER Location: N

ADA ID: RPRK211028172433 Ramp Type: Type 1 - Perpendicular Diagonal Initial Pass/Fail: Pass Overall Compliance: No Severity Score: 20

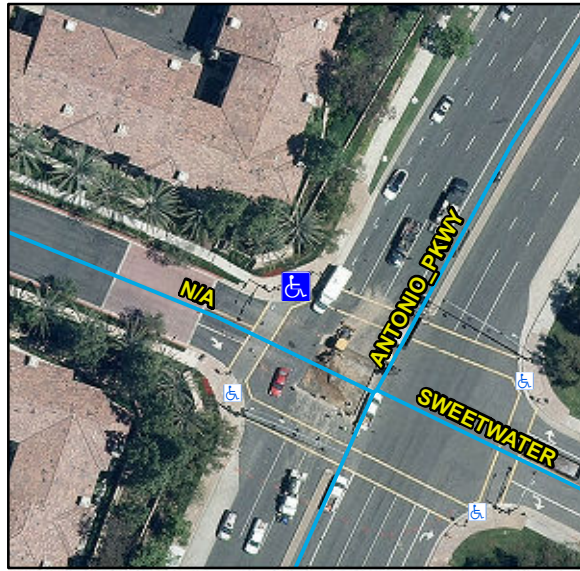
Compliance	Description	Data	Compliance	Description	Data
N/A	Ramp Length (in)	99	N/A	Flare Type LT	
Yes	Ramp Width (in)	48		Flare Slope LT (%)	9.7
Yes	Ramp Run Slope (%)	7	N/A	Flare Traversable LT	No
Yes	Ramp Cross Slope (%)	0.9	N/A	Flare Type RT	
N/A	Landing Present	Yes		Flare Slope RT (%)	6.5
N/A	Landing Length (in)	36		Flare Traversable RT	No
Yes	Landing Width (in)	48	N/A	DWS Provided	No
Yes	Landing Run Slope (%)	0.7	N/A	DWS Contrast	N/A
Yes	Landing Cross Slope (%)	1.4	No	DWS Length (in)	N/A
N/A	Landing Movement Obstructed?	No	N/A	DWS Full Width	N/A
	Landing Movement Type	N/A	N/A	DWS Offset Left (in)	N/A
N/A	Landing Shared	Yes	N/A	DWS Offset Right (in)	N/A
Yes	Clear Space	Yes	N/A	Marked Crosswalk 1	Yes
Yes	Clear Space To Crosswalk (in)	48	N/A	Crossing 1 Direction	SW
N/A	Marked Crosswalk 1	Yes	N/A	Crossing 2 Direction	SE
	Crossing 1 Width (in)	144		Marked Crosswalk 2 Width (in)	144
Yes	Ramp Inside Crosswalk 1	Yes	Yes	Ramp Inside Crosswalk 2	Yes

Crossing 1 Slope (%)	2.1		Crossing 1 Slope (%)	7
	Crossing 1 Cross Slope (%)	0.5		Crossing 2 Slope (%)	2.1
Yes	Gutter Ponding	No	No	Curb Slope	6.8
Yes	Gutter Lip Height (in)	0		Road Run Slope (%)	0.7
No	Gutter Run Slope (%)	11.7		Road Cross Slope (%)	2.5
Yes	Gutter Cross Slope (%)	0.4			
Yes	Overall Surface Condition: Acceptable		Yes	Perp Joint Present	Yes
	Cross Gutter Present?	No		Spandrel Present?	No
	Replace Cross Gutter?	N/A		Replace Spandrel?	N/A

Possible Solutions:
Remove & Replace Curb Ramp With Two New Directional Ramps or Equivalent. Remove & Replace Gutter.

OC Std/PROW:
 R304.2.2, R304.2.1, R305, R304.5.4, STD 1115
