# Access Compliance Report Public Rights-of-Way (Curb Ramps)

Main Street: MERCANTILE\_WAY Cross Street: WINDMILL\_AVE Location: NE

ADA ID: RPRK211029114712 Ramp Type: Type 4 - Parallel Initial Pass/Fail: Fail Overall Compliance: No Severity Score: 45

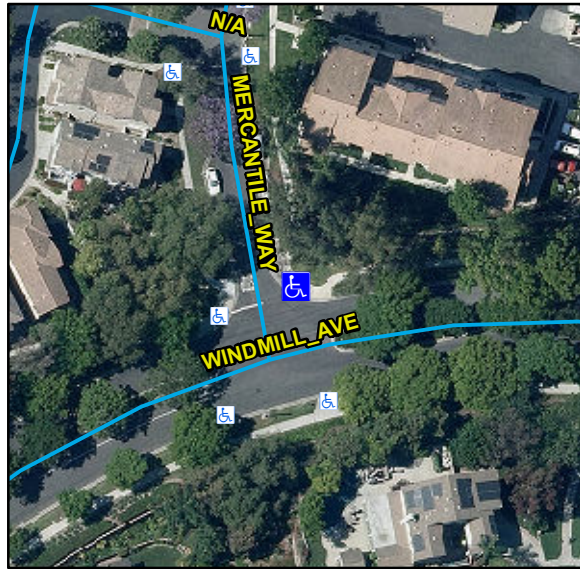
| Compliance | Description | Data | Compliance | Description | Data |
|---|---|---|---|---|---|
| N/A | Ramp Length LT (in) | 106 | N/A | Ramp Length RT (in) | 110 |
| Yes | Ramp Width LT (in) | 90 | Yes | Ramp Width RT (in) | 90 |
| Yes | Ramp Run Slope LT (%) | 2.7 | No | Ramp Run Slope RT (%) | 11.7 |
| No | Ramp Cross Slope LT (%) | 8 | No | Ramp Cross Slope RT (%) | 5.2 |

Remove & Replace Curb Ramp With Two New Directional Ramps or Equivalent.

R204.3, R304.5.3, R304.3.2, STD 1115
