# Access Compliance Report Public Rights-of-Way (Curb Ramps)

Main Street: WINDMILL\_AVE Cross Street: MERCANTILE\_WAY Location: NW

ADA ID: RPRK211029115156 Ramp Type: Type 4 - Parallel Initial Pass/Fail: Fail Overall Compliance: No Severity Score: 32

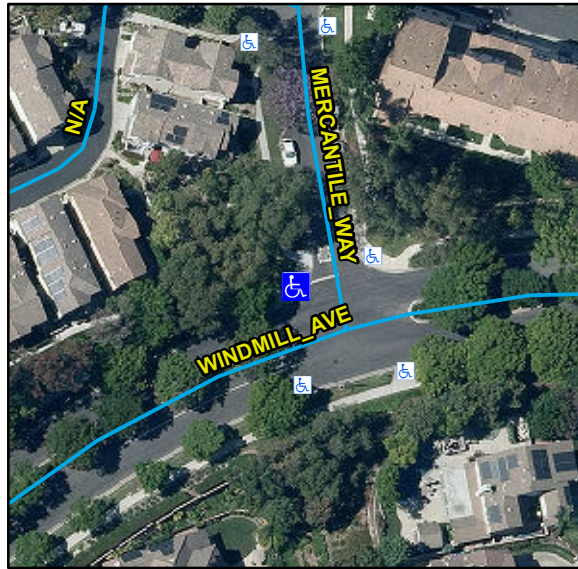
| Compliance | Description | Data | Compliance | Description | Data |
|---|---|---|---|---|---|
| Yes | Ramp Run Slope LT (%) | 4.8 | No | Ramp Run Slope RT (%) | 12.4 |
| No | Ramp Cross Slope LT (%) | 4.4 | No | Ramp Cross Slope RT (%) | 2.6 |

Remove & Replace Curb Ramp With Two New Directional Ramps or Equivalent.

R204.3, R304.5.3, R304.3.2, STD 1115
