# Access Compliance Report Public Rights-of-Way (Curb Ramps)

Main Street: **MERCANTILE\_WAY** Cross Street: **N/A** Location: **SW**

ADA ID: **RPRK211029120249** Ramp Type: **Type 4 - Parallel** Initial Pass/Fail: **Fail** Overall Compliance: **No** Severity Score: **15**

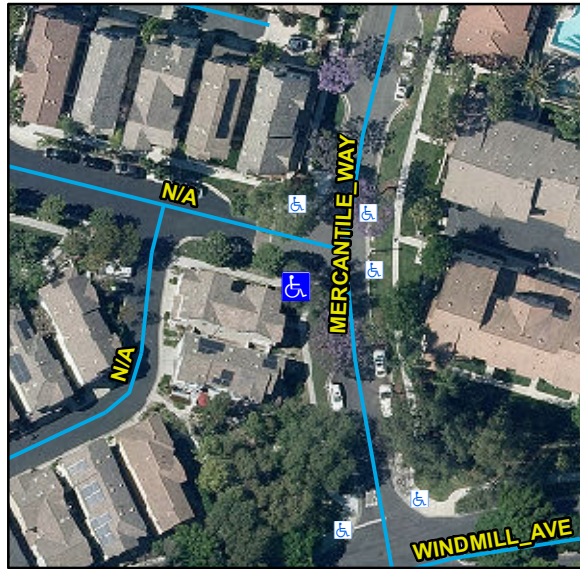
| Compliance | Description | Data | Compliance | Description | Data |
|---|---|---|---|---|---|
| <b>No</b> | Ramp Cross Slope LT (%) | <b>3.9</b> | <b>No</b> | Ramp Cross Slope RT (%) | <b>7</b> |

**Remove & Replace Curb Ramp With Two New Directional Ramps or Equivalent.**
