# Access Compliance Report Public Rights-of-Way (Curb Ramps)

Main Street: N/A Cross Street: MERCANTILE\_WAY Location: N

ADA ID: RPRK211029120746 Ramp Type: Type 4 - Parallel Initial Pass/Fail: Fail Overall Compliance: No Severity Score: 30

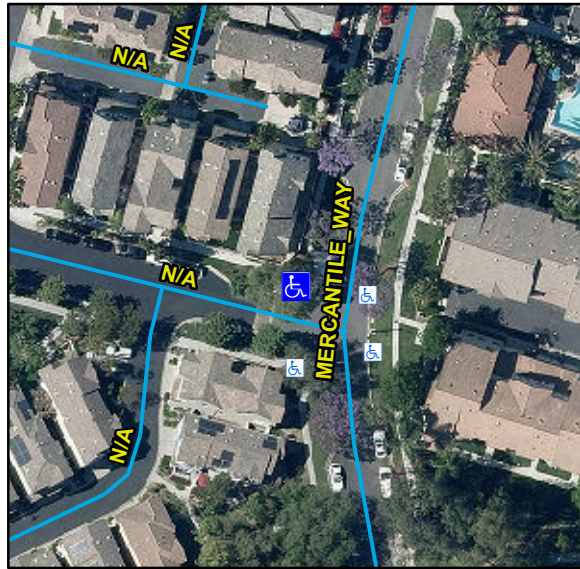
| Compliance | Description | Data | Compliance | Description | Data |
|---|---|---|---|---|---|
| Yes | Ramp Run Slope LT (%) | 4.3 | No | Ramp Run Slope RT (%) | 10.9 |
| No | Ramp Cross Slope LT (%) | 5.7 | No | Ramp Cross Slope RT (%) | 4.9 |

**Remove & Replace Curb Ramp With Two New Directional Ramps or Equivalent.**

**R204.3, R304.5.3, R304.3.2, STD 1115**
