# Access Compliance Report Public Rights-of-Way (Curb Ramps)

Main Street: N/A Cross Street: MERCANTILE\_WAY Location: S

ADA ID: RPRK211029122153 Ramp Type: Type 4 - Parallel Initial Pass/Fail: Fail Overall Compliance: No Severity Score: 2

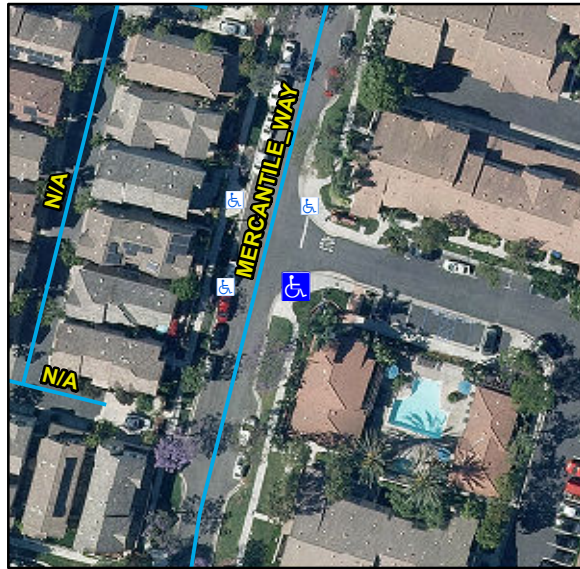
| Compliance | Description | Data | Compliance | Description | Data |
|---|---|---|---|---|---|
| Yes | Ramp Run Slope LT (%) | 7.7 | Yes | Ramp Run Slope RT (%) | 3.4 |
| Yes | Ramp Cross Slope LT (%) | 0.8 | No | Ramp Cross Slope RT (%) | 3.8 |
| N/A | Gutter Ponding | N/A | No | Curb Slope | 13.2 |

Remove & Replace Curb Ramp With Two New Directional Ramps or Equivalent.

R304.2.2, R204.3, R304.5.3, STD 1115

Total Cost: \$ 4000
