# Access Compliance Report Public Rights-of-Way (Curb Ramps)

| Main Street: <b>MERCANTILE_WAY</b> | | Cross Street: <b>N/A</b> | | Location: <b>E</b> |
| ADA ID: <b>RPRK211029122532</b> | Ramp Type: <b>Type 4 - Parallel</b> | Initial Pass/Fail: <b>Fail</b> | Overall Compliance: <b>No</b> | Severity Score: <b>30</b> |

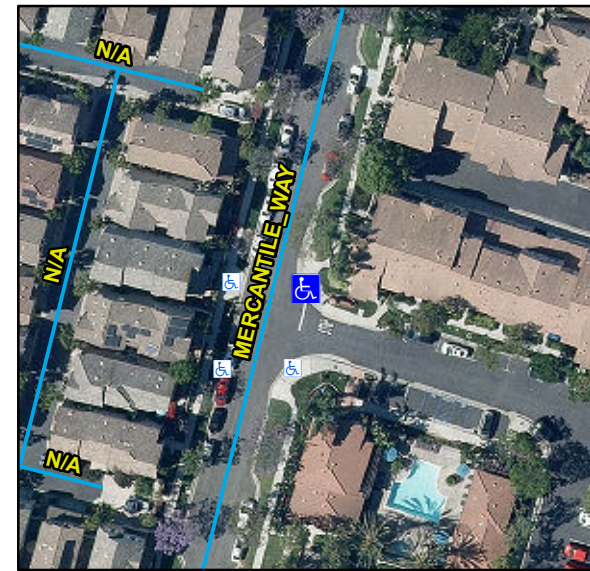
| Compliance | Description | Data | Compliance | Description | Data |
|---|---|---|---|---|---|
| <b>Yes</b> | Ramp Cross Slope LT (%) | <b>1.4</b> | <b>No</b> | Ramp Cross Slope RT (%) | <b>9.5</b> |

**Remove & Replace Curb Ramp With Two New Directional Ramps or Equivalent.**

**R204.3, R304.5.3, STD 1115**
