# Access Compliance Report Public Rights-of-Way (Curb Ramps)

Main Street: **MERCANTILE\_WAY** Cross Street: **N/A** Location: **N**

ADA ID: **RPRK211029123450** Ramp Type: **Type 1 - Perpendicular** Initial Pass/Fail: **Fail** Overall Compliance: **No** Severity Score: **15**

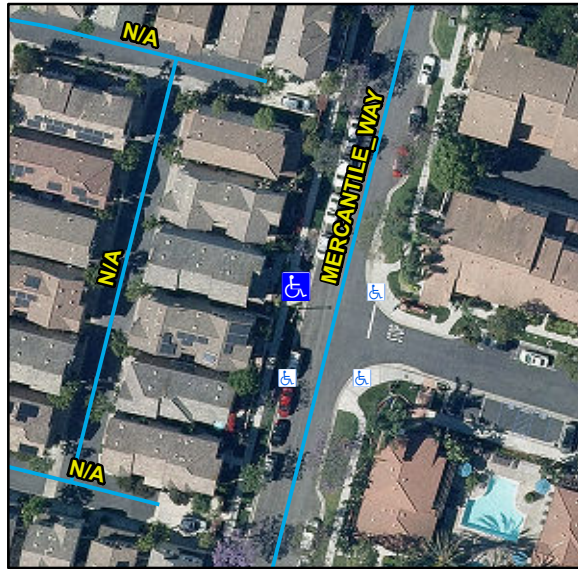
| Compliance | Description | Data | Compliance | Description | Data |
|---|---|---|---|---|---|
| No | Ramp Cross Slope (%) | 5.5 | N/A | Flare Traversable LT | N/A |
| N/A | Gutter Ponding | N/A | No | Curb Slope | 5.5 |

**Remove & Replace Entire Ramp.**

**R304.2.2, R204.3, R304.5.3, STD 1115**
