# Access Compliance Report Public Rights-of-Way (Curb Ramps)

Main Street: **MERCANTILE\_WAY** Cross Street: **THIRD\_RD** Location: **SE**

ADA ID: **RPRK211029123830** Ramp Type: **Type 1 - Perpendicular** Initial Pass/Fail: **Pass** Overall Compliance: **No** Severity Score: **16**

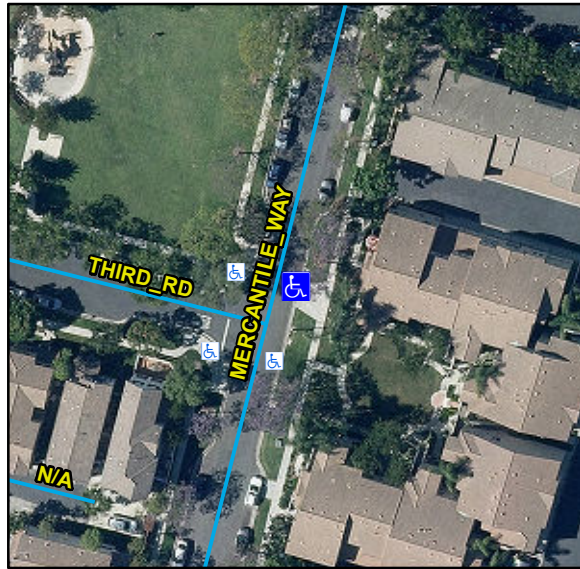
| Compliance | Description | Data | Compliance | Description | Data |
|---|---|---|---|---|---|
| <b>No</b> | Landing Run Slope (%) | <b>3.4</b> | <b>N/A</b> | Flare Traversable RT | <b>No</b> |
| <b>Yes</b> | Landing Cross Slope (%) | <b>1.7</b> | <b>No</b> | DWS Provided | <b>No</b> |
| <b>Yes</b> | Gutter Ponding | <b>No</b> | <b>No</b> | Curb Slope | <b>7.3</b> |
| <b>No</b> | Gutter Run Slope (%) | <b>8.6</b> | | Road Cross Slope (%) | <b>N/A</b> |

**Remove & Replace Entire Ramp. Remove & Replace Gutter.**
