# Access Compliance Report Public Rights-of-Way (Curb Ramps)

Main Street: SECOND\_ST Cross Street: SECOND\_ST Location: S

ADA ID: RPRK211029124309 Ramp Type: Type 4 - Parallel Initial Pass/Fail: Fail Overall Compliance: No Severity Score: 2

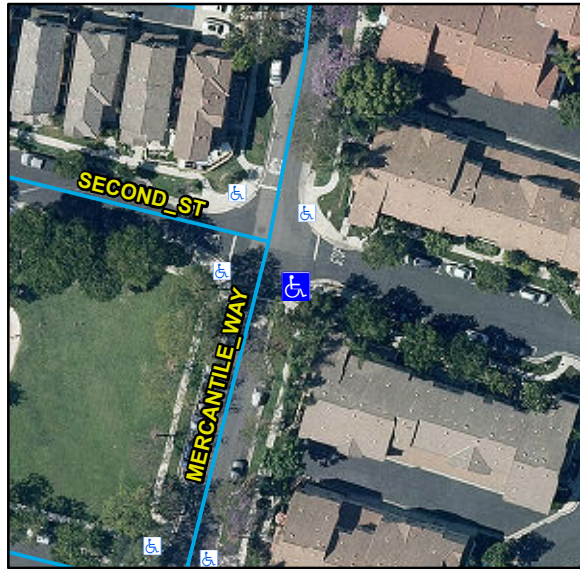
| Compliance | Description | Data | Compliance | Description | Data |
|---|---|---|---|---|---|
| No | Ramp Cross Slope LT (%) | 3.8 | No | Ramp Cross Slope RT (%) | 2.7 |

**Remove & Replace Curb Ramp With Two New Directional Ramps or Equivalent.**

**R204.3, R304.5.3, STD 1115**
